INITIAL ASSESSMENT, LANDRY TOMB, DONALDSONVILLE, LA

Prepared By:
Michael Trinkley, Ph.D.

CHICORA RESEARCH CONTRIBUTION 516

May 2009

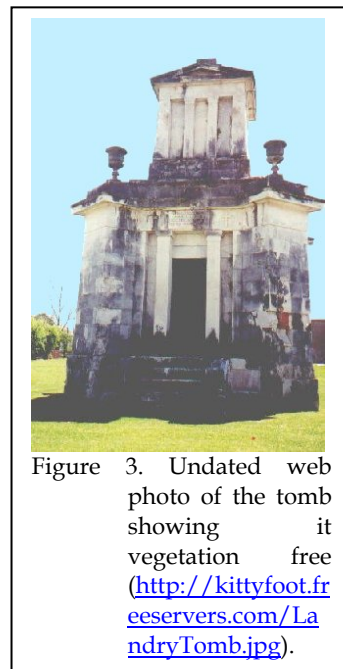
The photographs associated with this report provide little detail, although they do indicate considerable vegetation. This extensive growth, however, has not always been so overwhelming. At least one undated photograph found on the web shows the tomb with no evidence of vines (Figure 3).

Figure 3. Undated web photo of the tomb showing it vegetation free (<http://kittyfoot.fr.eeservers.com/LandryTomb.jpg>).

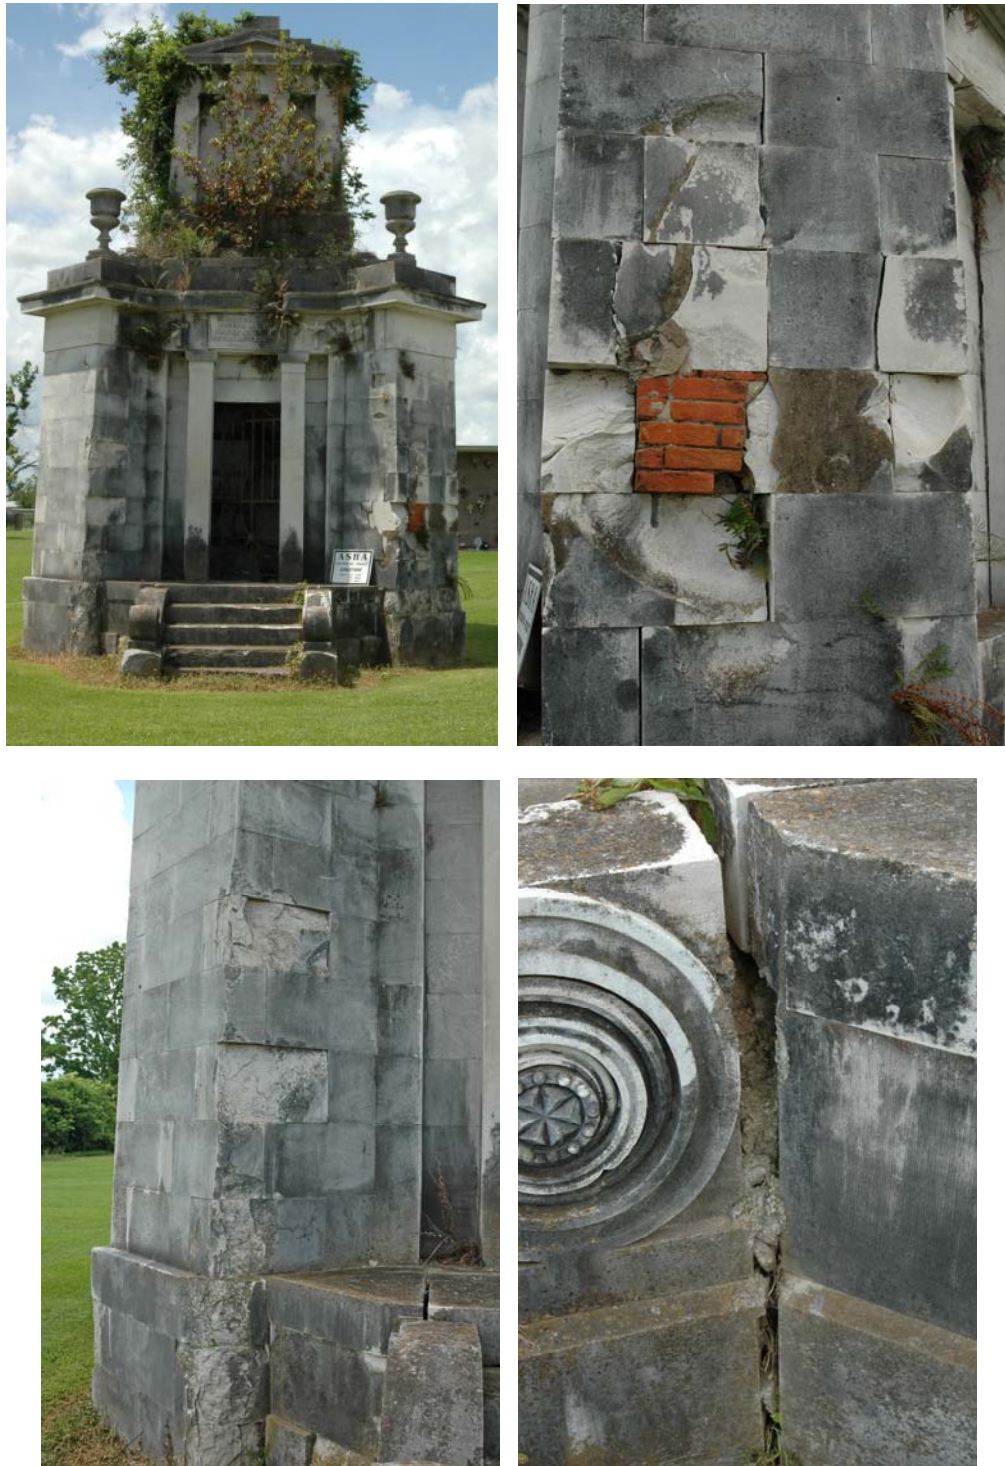
Figure 4 shows the north face of the Landry Tomb. This north elevation is the front of the tomb and centered are steps leading to the entrance. Vegetation is found growing from joints in the walls, but is primarily confined to the pavilion top. Condition of the pavilion was not ascertained because of the vegetation and the absence of a lift to allow close examination.

The cornice immediately above the entrance is damaged, with about 2' missing at the right and additional damage to the left. The ashlar stone is generally in good condition, except at the two corners from about midway down to the ground level. In these areas the stone is spalling. The diagonal pier to the right of the entrance exhibits three split stones. Two have been repaired (or partially repaired) using ordinary Portland cement (OPC). A portion of a third stone is missing, having been replaced with brickwork.

The steps themselves appear to have shifted away from the tomb and reveal an old repair effort using OPC on both the right and left sides in an effort to point the resulting gap. The left side has lost a portion of one stone, while on the right side a similarly displaced stone has been inappropriately and only partially replaced using white Portland cement (Figure 5).

Figure 4. Landry Tomb, north elevation. Top left shows façade; top right shows damage to right diagonally set pier; bottom left shows damage to stones at the corner of the left pier; bottom right shows separation between tomb and steps on the right side.

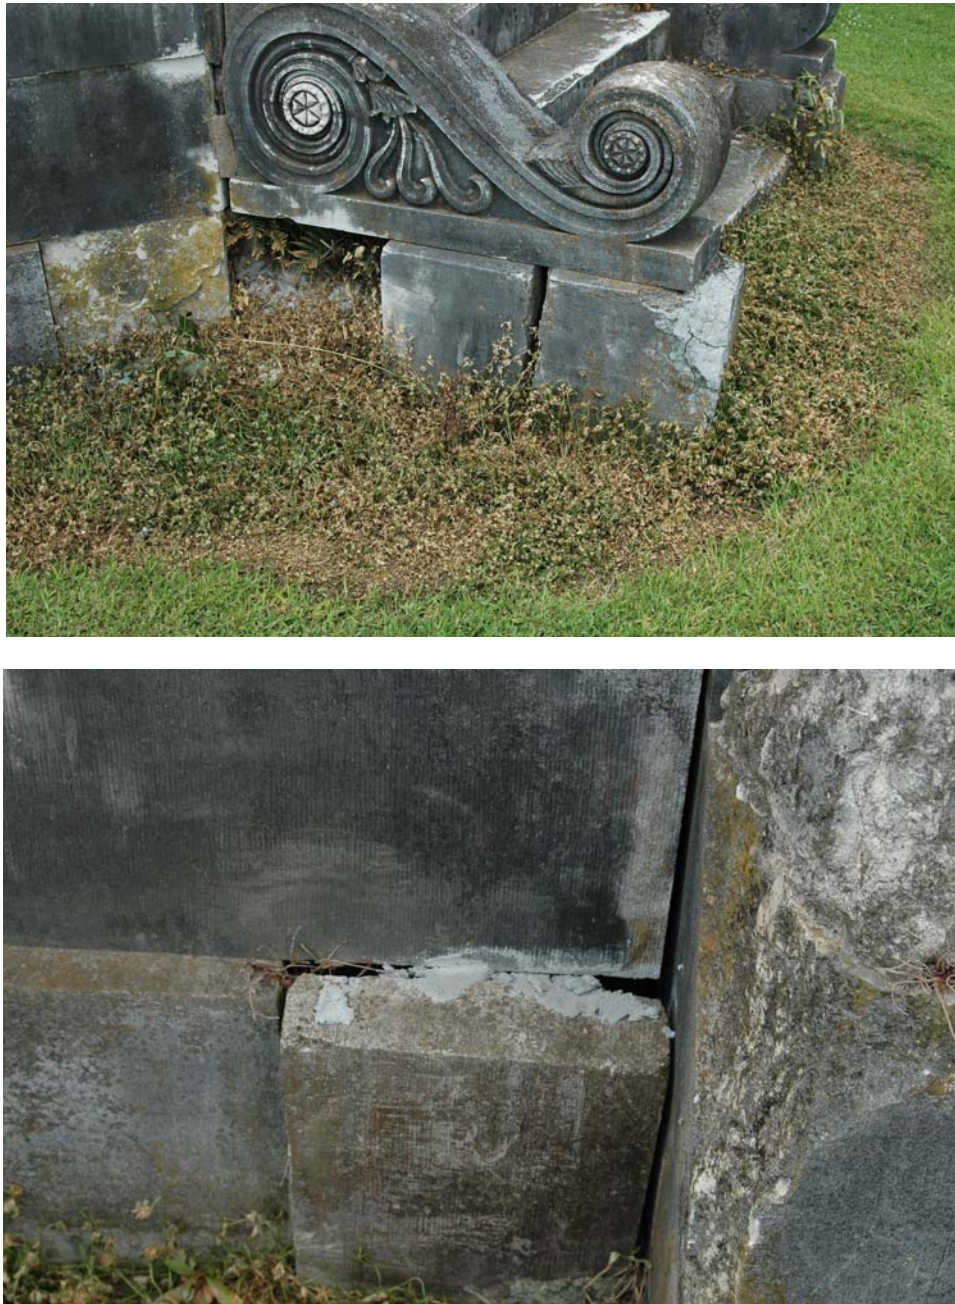
Figure 5. Landry Tomb, north elevation. Top photo left side of steps showing spalled stone and separation from the tomb. Bottom photo right side of steps showing effort to replace fallen ashlar block.

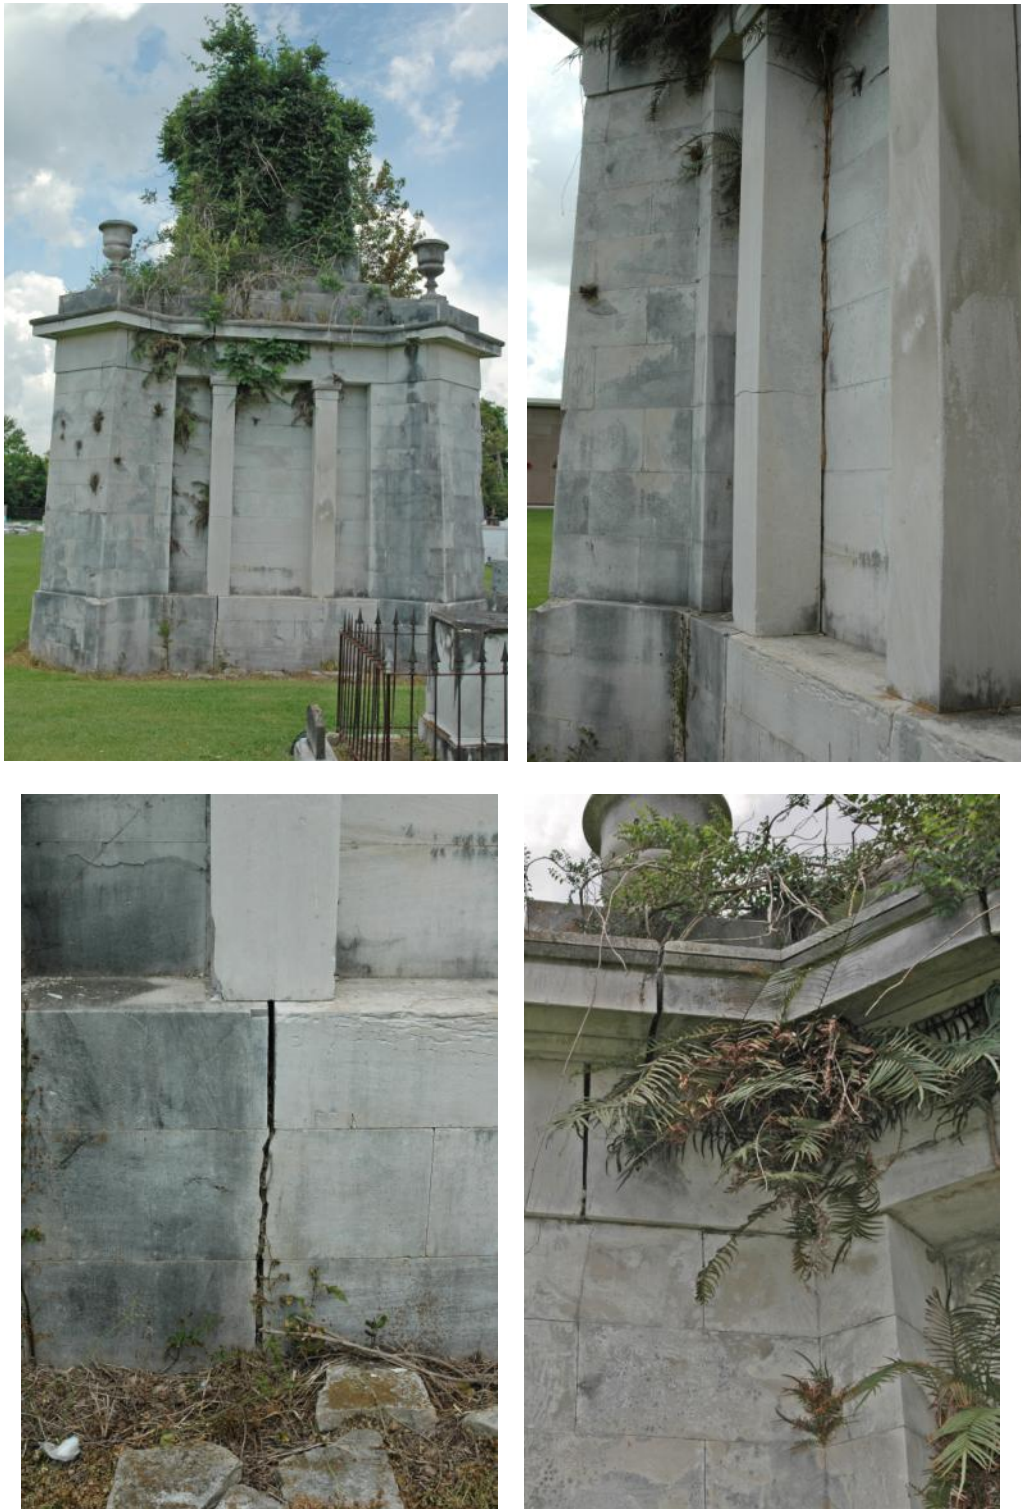
Figure 6 shows the east elevation. Vines are very heavy on this side, almost completely obscuring the pavilion top.

The cornice, while intact, shows shifting outward, away from the tomb core, in two locations. In one area the shift is approximately $\frac{3}{4}$ ".

The left pilaster appears bowed and cracked about 3' up. It has also separated from the wall by about $\frac{3}{4}$ ". The foundation at the base of this left pilaster exhibits a diagonal crack about $\frac{1}{2}$ to $\frac{3}{4}$ " in thickness, representing both shifting and splitting of one block.

Figure 6. Landry Tomb, east elevation. Top left shows façade; top right shows shifted and cracked pilaster; bottom left shows foundation crack; bottom right shows shifted cornice.

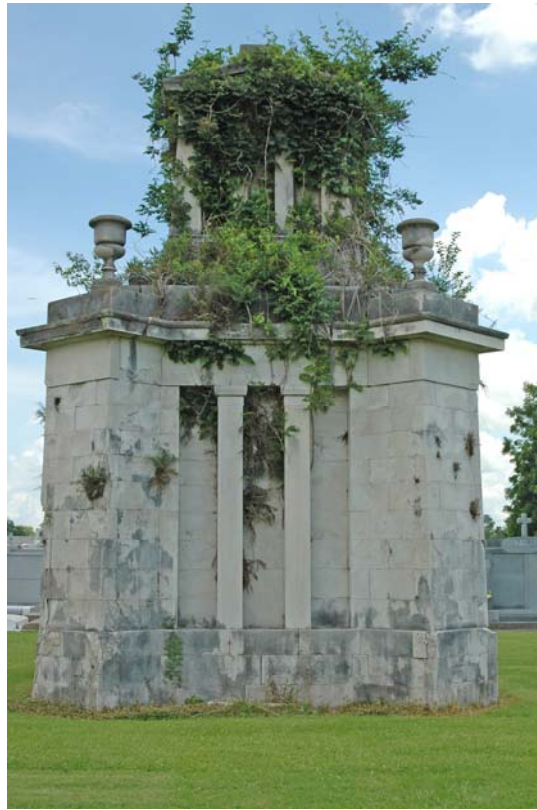
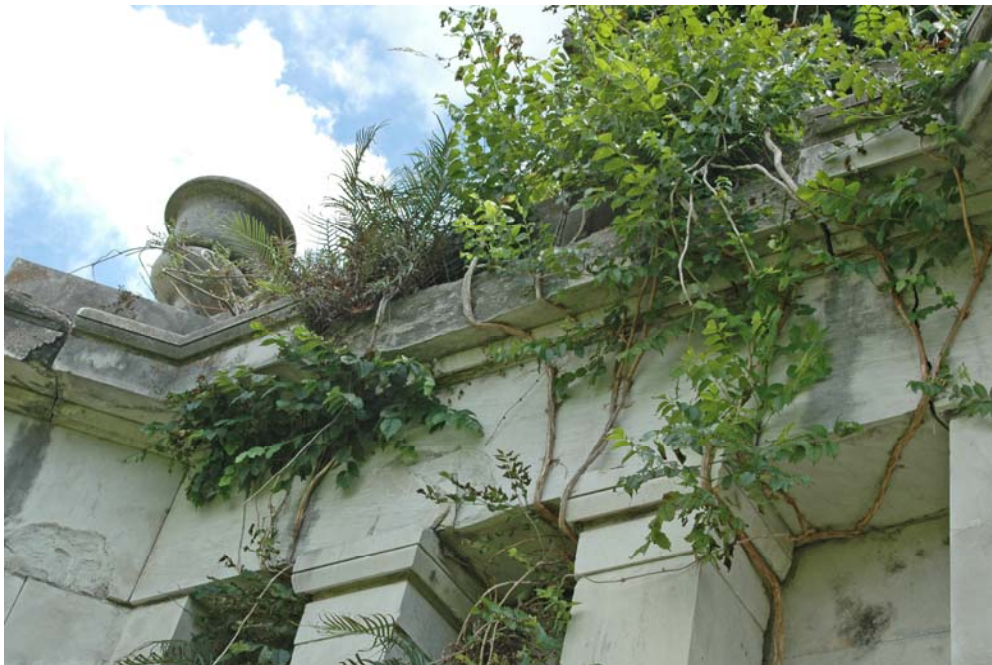
The south elevation at first glance appears unremarkable. It exhibits the same degree of vegetation found on the north and east facades, as well as a similar soiling pattern. Stone damage seems most severe at the corners.

The right pilaster, however, has shifted out at the base about $1\frac{1}{4}$ ". This may be the one shift previously noted by Chaux Vive.

There is also extensive damage to the cornice, with the loss of about a 6' foot section. Additional damage is seen to the left of this central area of loss.

Figure 7. South elevation of the Landry Tomb. Top photo is the façade. Bottom photo shows loss of the cornice and extensive growth.

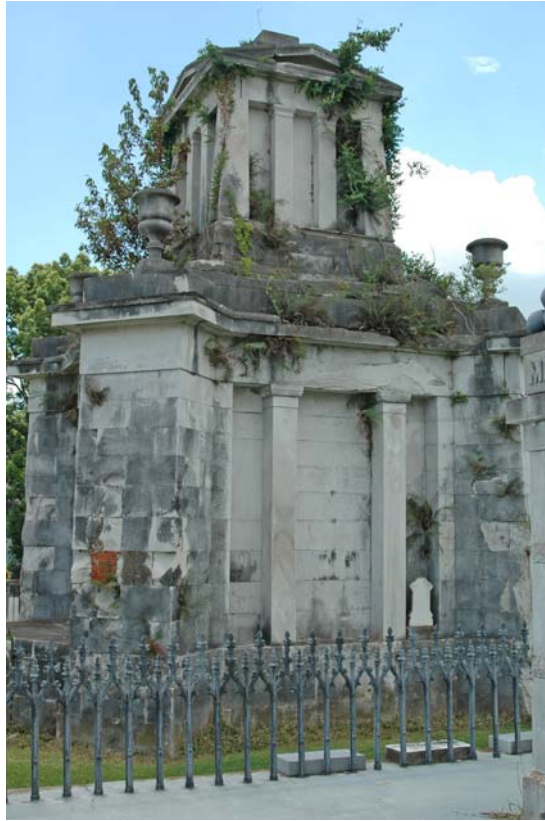
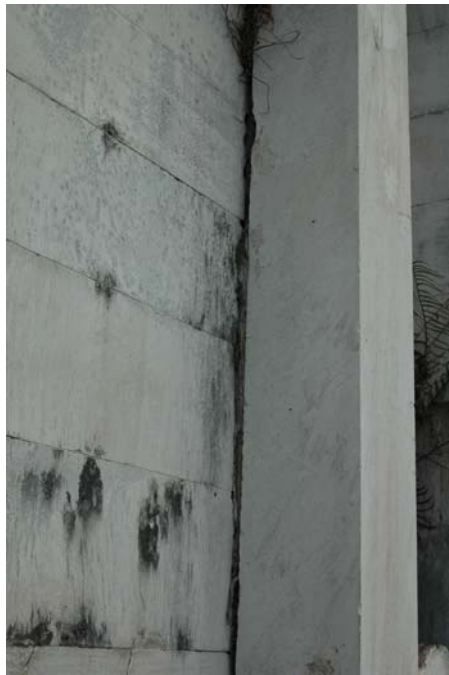
The west elevation (Figure 8) reveals damage to the upper pavilion, including stone loss. Immediately below this a 7 to 8' section of the cornice has been lost and there is extensive stone spalling below.

Figure 8. Landry Tomb, west elevation. Top shows façade. Bottom shows pilaster shift in the middle.

The right pilaster is displaced about $\frac{3}{4}$ " at the bottom and about 1" at the top. It, like the others, appears to be shifted by the extensive vine growth originating below.

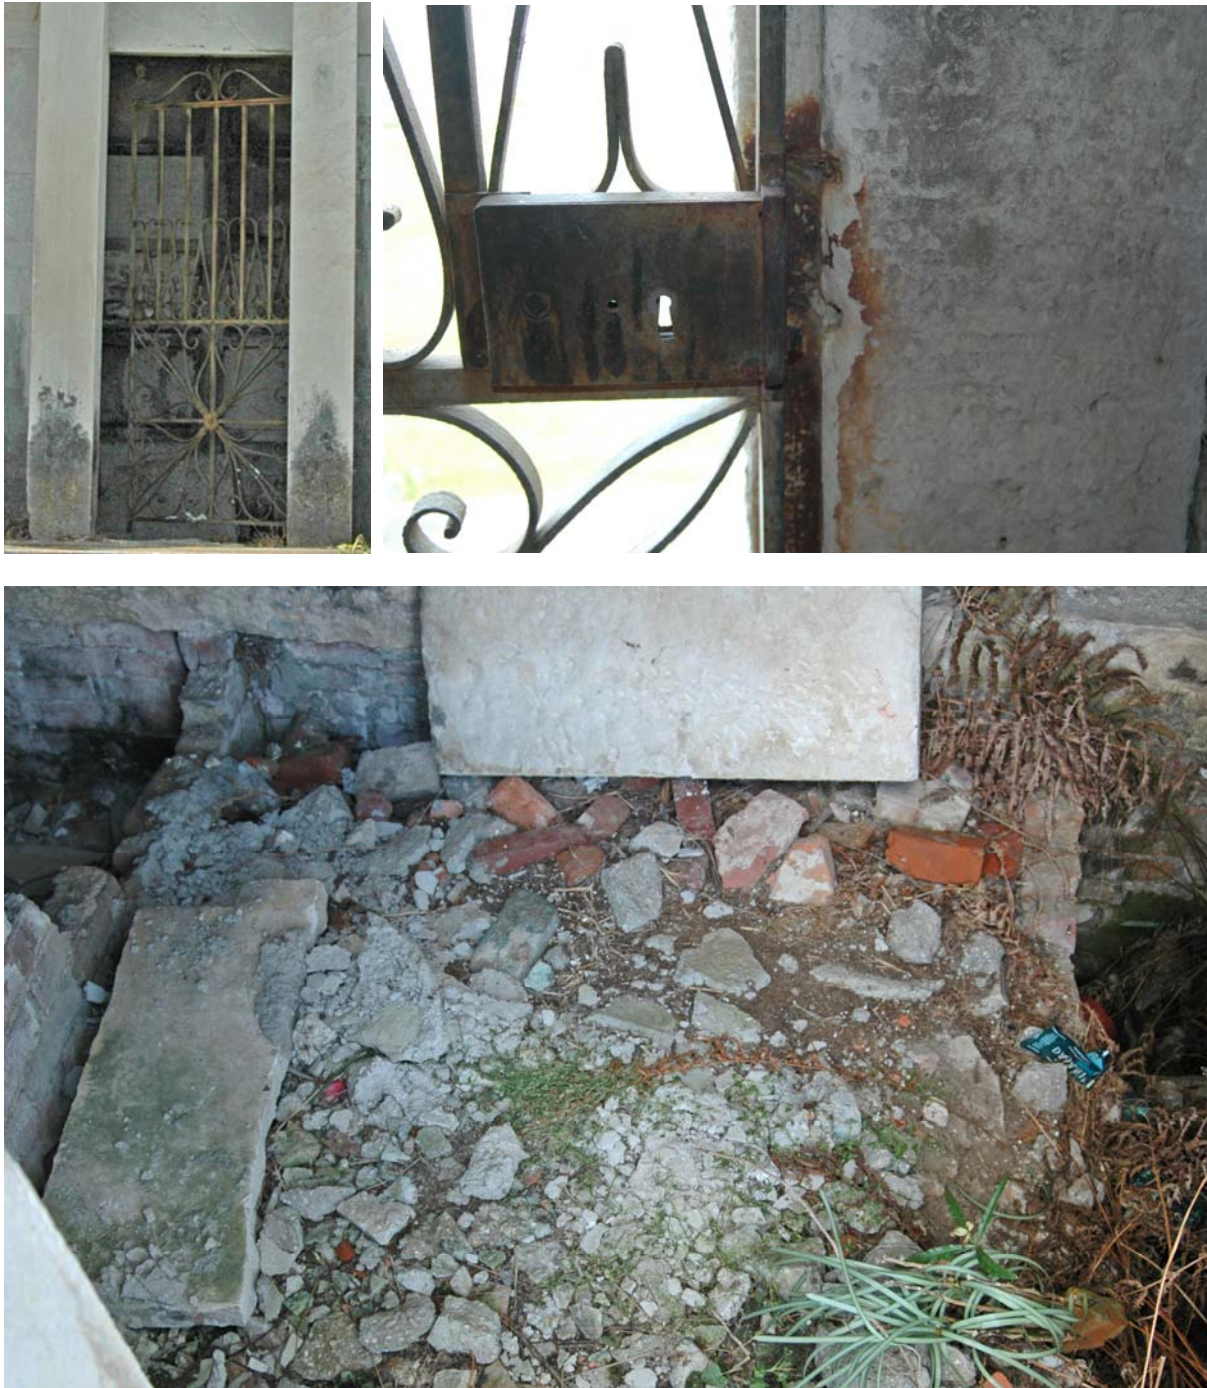
Figure 9. Door and tomb interior. Upper left, filigree door from exterior. Upper right, interior view of the rim lock and missing lock keeper. Lower photo showing the interior floor with trash, vegetation, and architectural debris.

The tomb is guarded by an inward opening iron filigree door that is intact. It exhibits relatively little corrosion and it has been previously painted white. Its closure consists of a rim lock with an exterior knob. The lock keep on the interior of the stone jamb is missing.

The existing iron door is in good condition, although its ability to secure the tomb is limited.

A temporary eye bolt can be set in the interior wall and a chain and padlock used. The eye bolt, once removed can be patched over. A more sensitive approach, however, would be to replace the missing lock keeper. Cast iron examples are widely available from antique lock dealers (see, for example, <http://houseofantiquehardware.com/s.nl/sc.10/category.163/.f>) or one can be readily fabricated to fit existing holes. The existing lock can be removed and repaired by an antique locksmith, although ideally a locksmith may be able to do the necessary repairs on-site. For example, H. Rault Locksmith in New Orleans has some experience with antique materials.

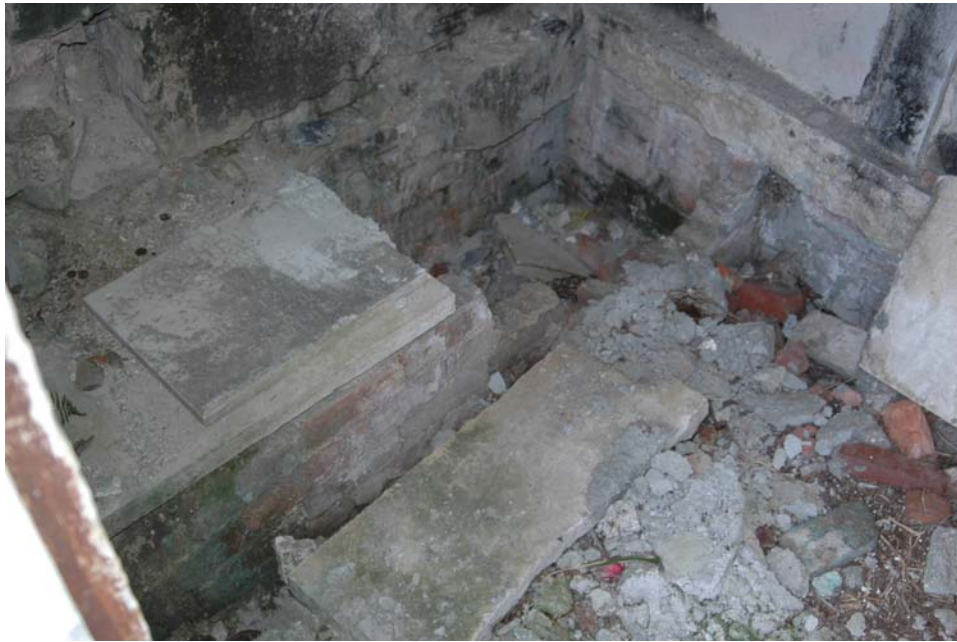
Figure 10. Interior left of the Landry tomb showing one of the four floor vaults partially open.

The interior floor appears to have contained 4 vaults, with an additional 20 more built into the south wall. While the center two vaults appear intact, the eastern and western vaults appear damaged and partially excavated. The interior floor is scattered with architectural rubble and there is no hint of the original floor. Many, although not all, of the marble tomb plaques are still in place.

Assuming that there are no structural contradictions, the interior floor can be readily stabilized by cleaning out the vestibule, removing vegetation and trash, and infilling the open holes with clean sand. This will not disturb any of the existing remains (human or archaeological) and will allow the interior to be put into some more reasonable appearance at a relatively low cost. Although it should be considered temporary, this is readily reversible.
